Navajo Abandoned Uranium Mine

Site Screen Report

White Cap AUM Site

March 2010

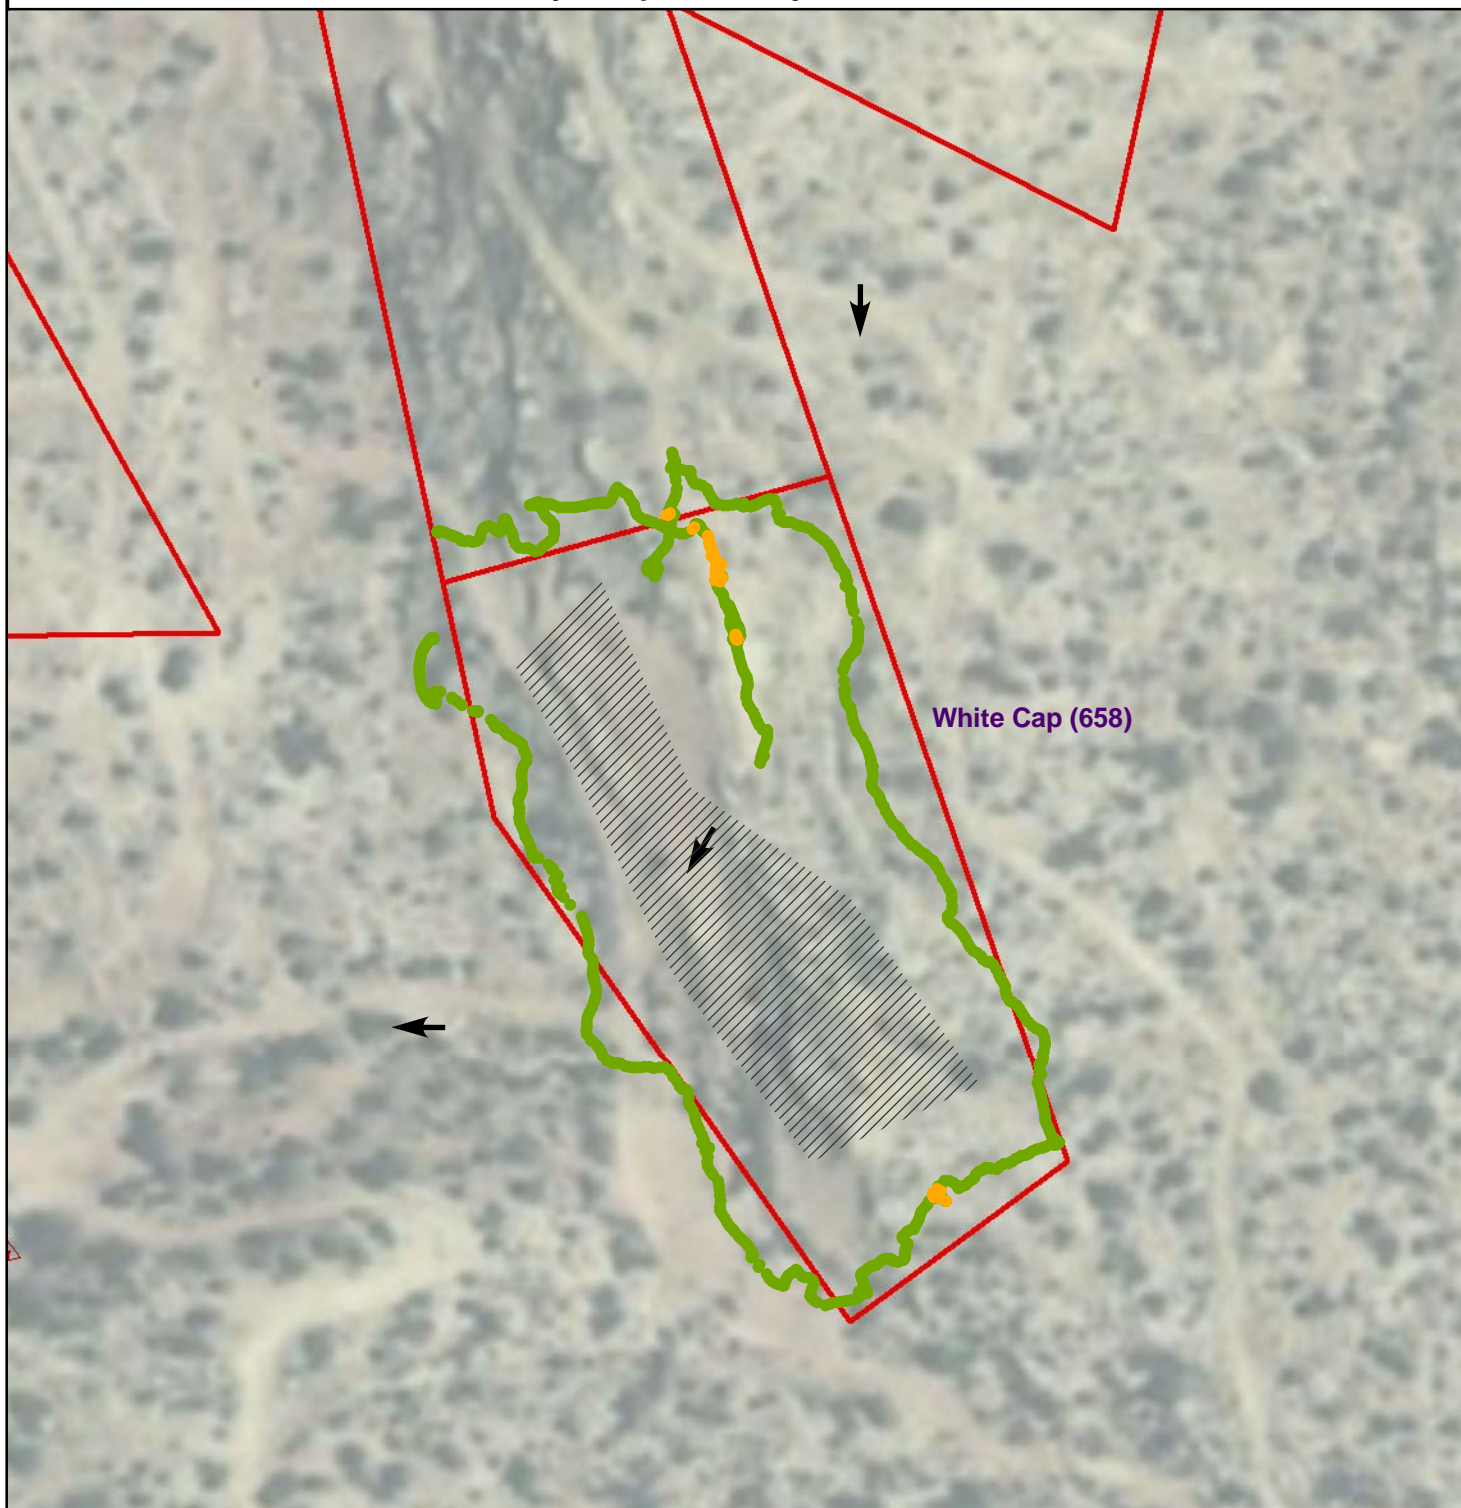
**Figure 1 - Gamma Radiation Measurements, Above Two Times Background
White Cap (658)
Red Valley Chapter, Navajo Nation, Arizona**

A total of 1,236 gamma radiation measurements were collected from the mine site, ranging from 7,179 cpm to 782,123 cpm. The highest readings were found in the northern portion of the site. The measurements are represented in Figures 1 and 2.

Gamma survey conducted 10/2009
Measured as counts per minute (cpm)

Average background = 11,055 cpm

Inaccessible due to steep grades
